Disassembly gear motor from deck side.

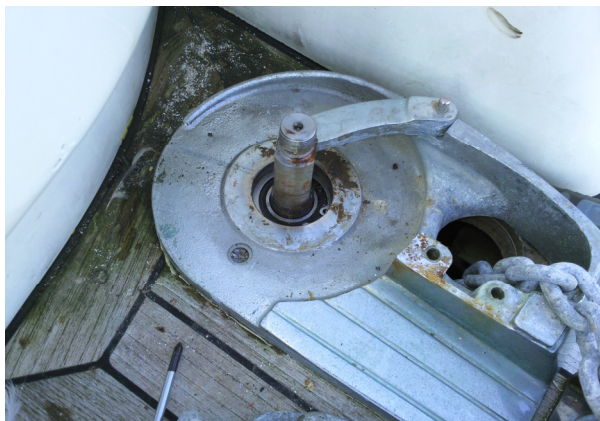
When disassembly the gear motor and the shaft is stuck in the gear box, this is how you can disassembly from deck side. Shaft get stuck if the installer has forgot to put grease on shaft when installing, or lack of maintenance

Remove al parts on shaft.
Remove clip part 12 ref to user manual.
Spray shaft with CRC565, WD40 or similar products.

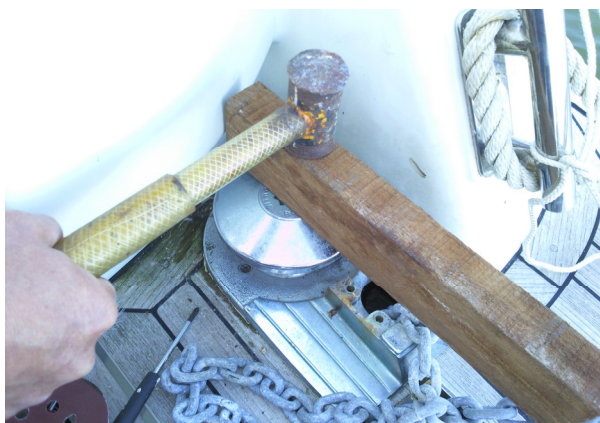
Low profile model:
Replace gypsy cap part 19, tighten normally.
Capstan model:
Replace capstan screw part 2, tighten normally.
Lay a wood piece between the gypsy cap / capstan screw so you don't damage when using a hammer.
Use the hammer to pushing the shaft down.

Note!
Do not use the hammer direct on the shaft, this will damage the treads on shaft.

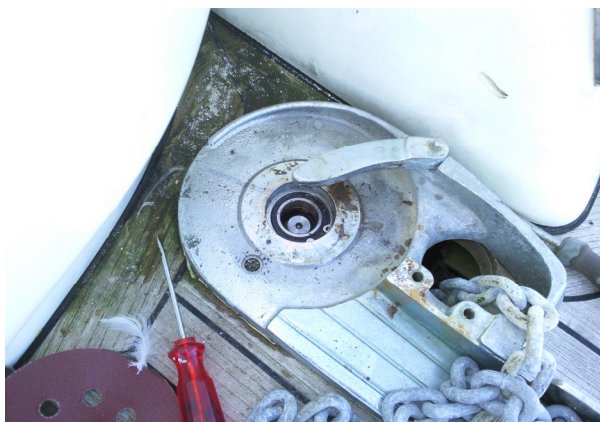
When the shaft is out of the deck unit.

Use the hammer to push the shaft out of the gear box, use some wood between the hammer and shaft so you don't damage the shaft.
